## Issue: Efflorescence on Concrete and Tile Surfaces

January 2025

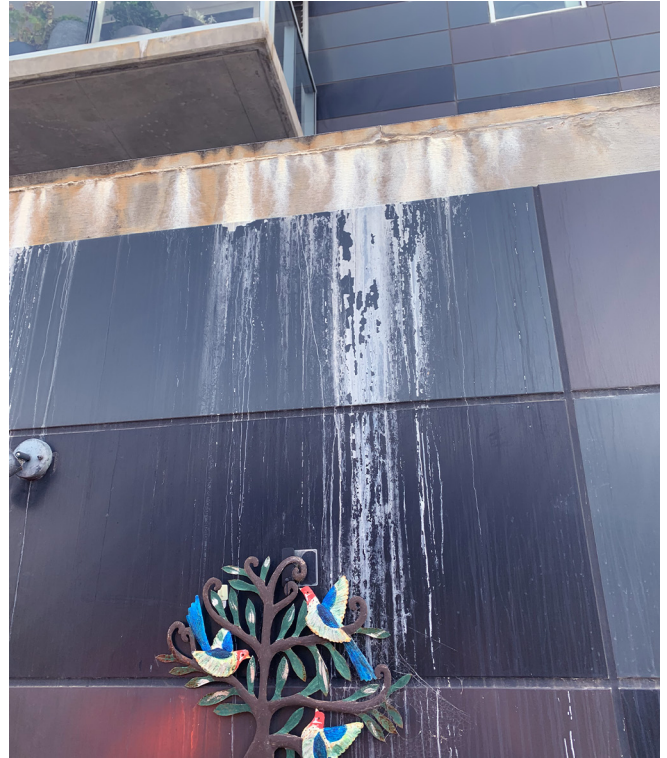
*Pic 1. Efflorescence is unsightly and can be costly to regularly clean.*

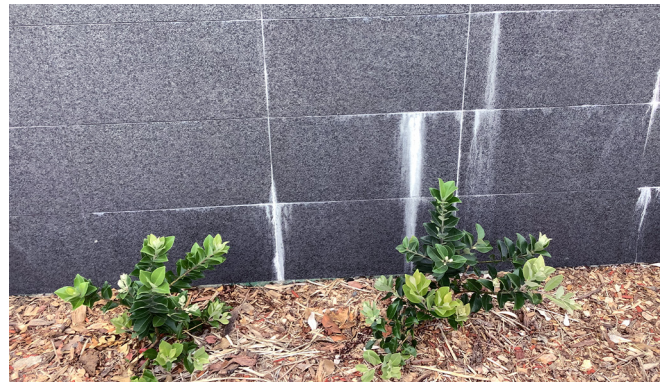
*Pic 2. Porous grouts provide entry and exit points for moisture.*

- **Use Materials with Low-Permeability.** **AS/NZS 4456.6** highlights the importance of using the correct adhesive and grout for tiling on masonry. Select adhesives, grouts, and concrete additives specifically designed to resist water absorption. An epoxy adhesive or grout helps to keep water from reaching the surface.

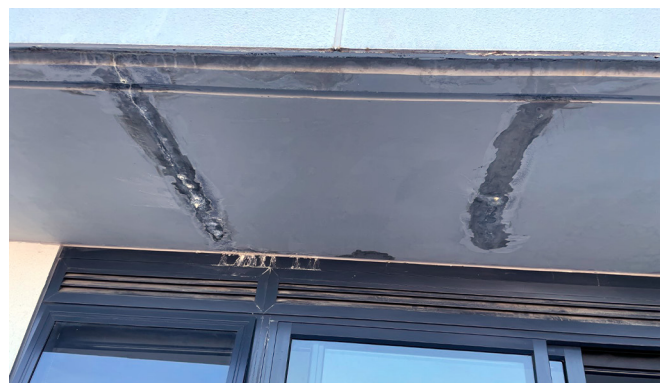
*Pic 3. Left unchecked, efflorescence will weaken structures.*

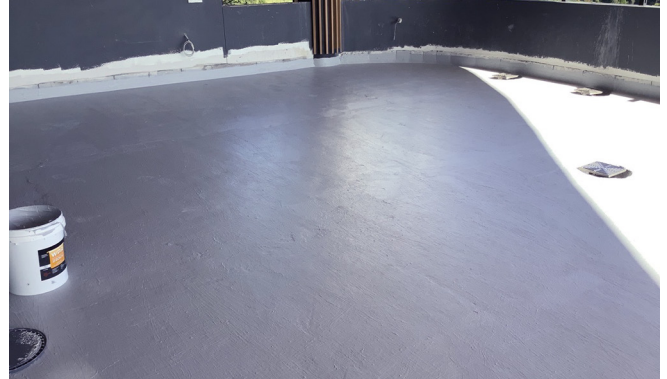
*Pic 4. Apply a membrane over the screed layer - allow time to cure!*

- **Proper Waterproofing.** Apply a high-quality waterproofing membrane over the screed to prevent trapped moisture from reaching the surface. Follow the manufacturer's guide for curing time and ensure the surface is clean and prepared before application.

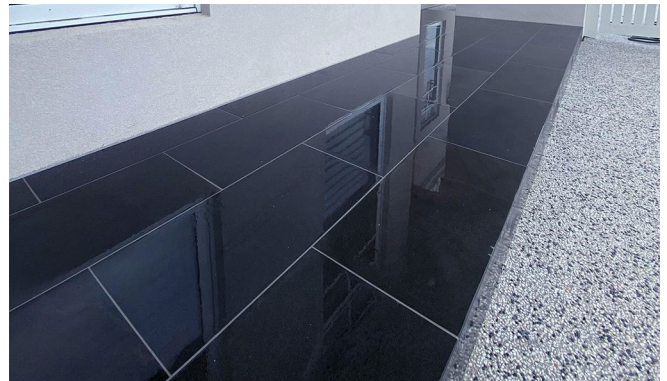
*Pic 5. Use epoxy adhesives and grouts to help prevent water ingress.*

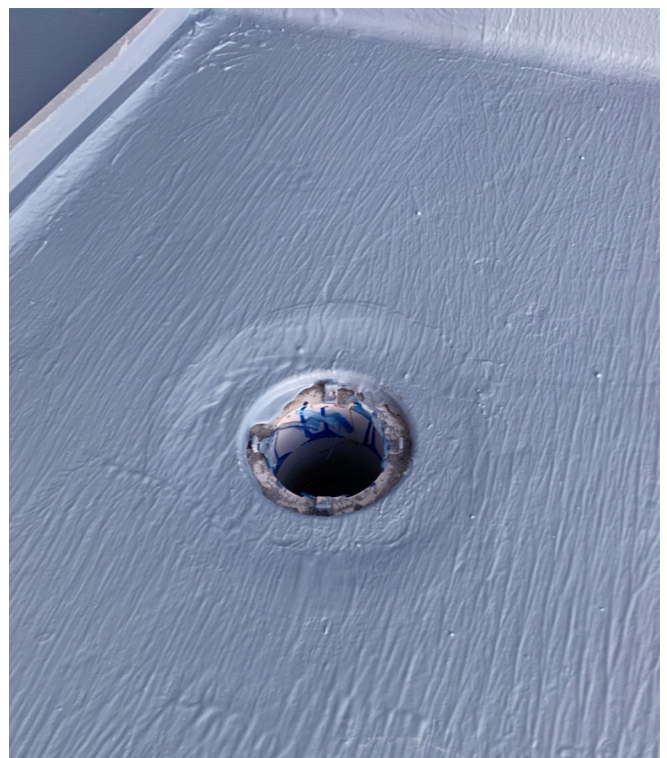
*Pic 6. A minimum fall of 1:100 is crucial to preventing efflorescence.*

- **Incorporate Effective Drainage Solutions.** Proper drainage is critical for external installations. **AS 4654.2** states that waterproofing membranes for external above-ground use should be installed with a minimum fall of 1:100 to ensure adequate water runoff. This prevents water pooling, which is a significant contributor to efflorescence.
